**Choptank Road (SR 15) Planning Study
PDC Project Handoff
May 15, 2002**

Purpose and Need Statement

Delaware SR 15 (Choptank Road) Bethel Church Road to Bunker Hill Road New Castle County, Delaware

Delaware Department of Transportation

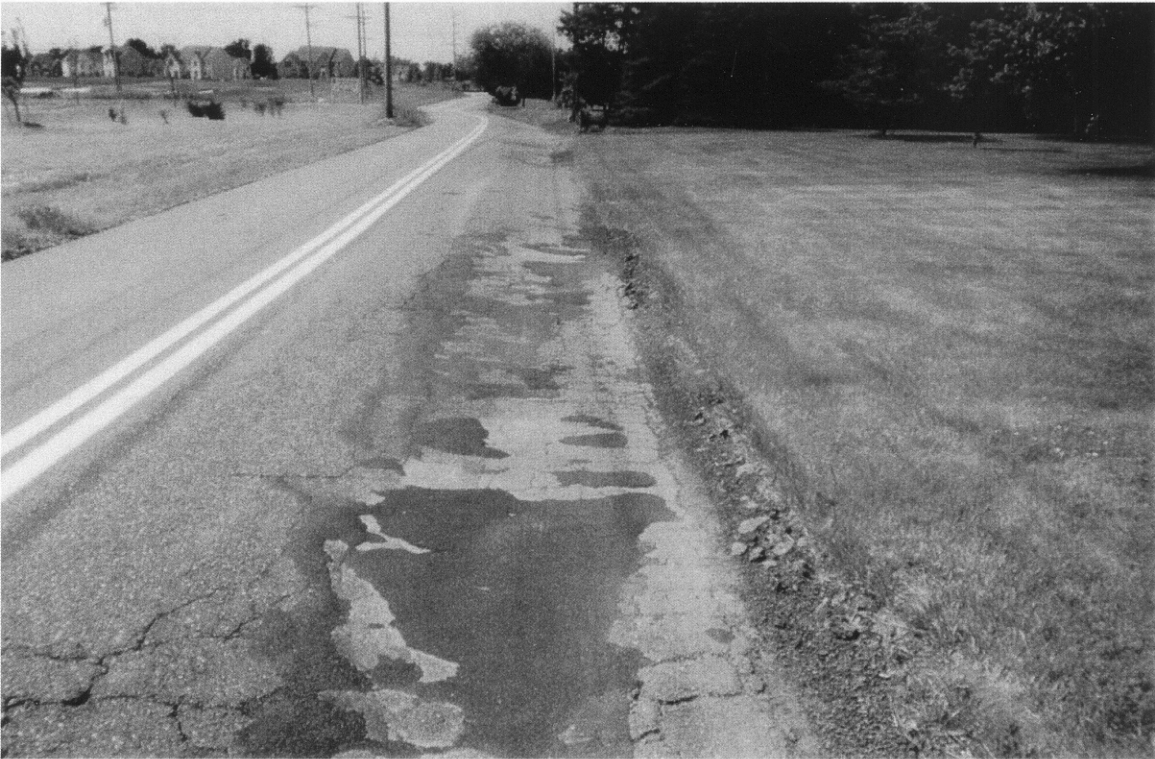
Pavement Failure on Northbound Choptank Road, approaching Churchtown Road

Minor flooding and standing water are frequently found along the roadside ditches and at the pavement edge. This saturates the soil, which leads to early pavement deterioration in numerous locations. (See photographs in Appendix A.) Truck weight restrictions have been posted on Choptank Road to limit heavy load traffic and minimize further pavement failure.

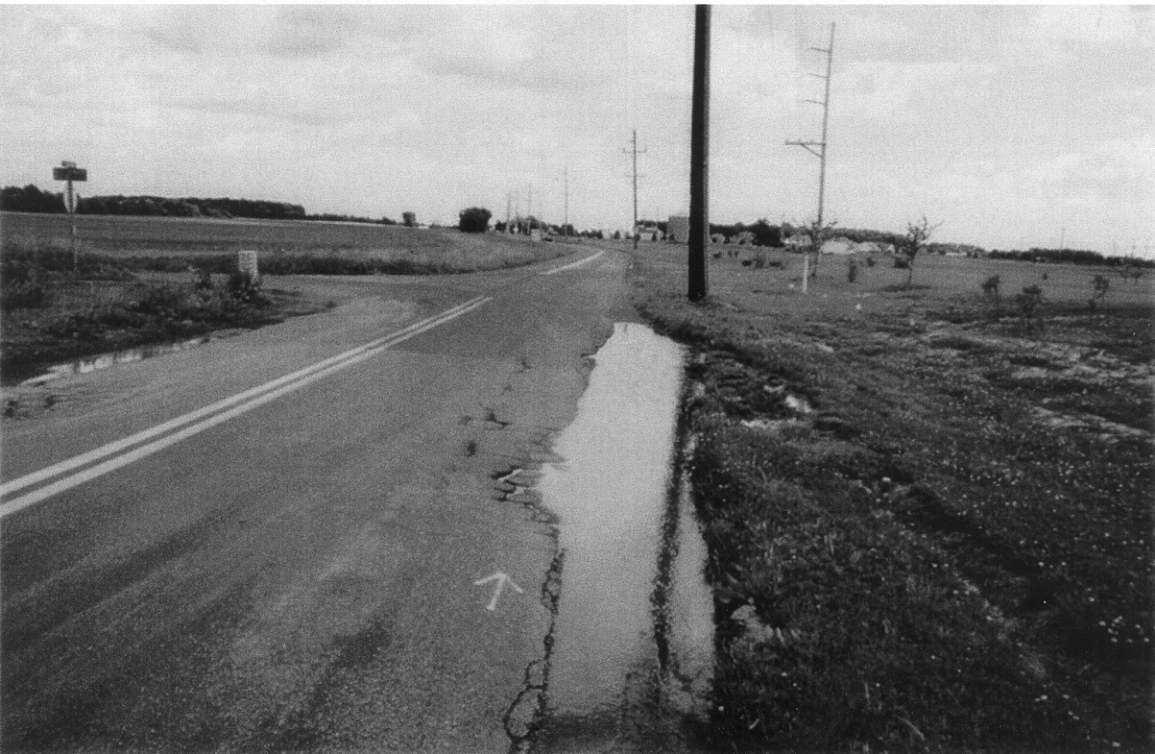
Standing Water and Pavement Failure on Both Sides of Choptank Road, North of Old Schoolhouse Road

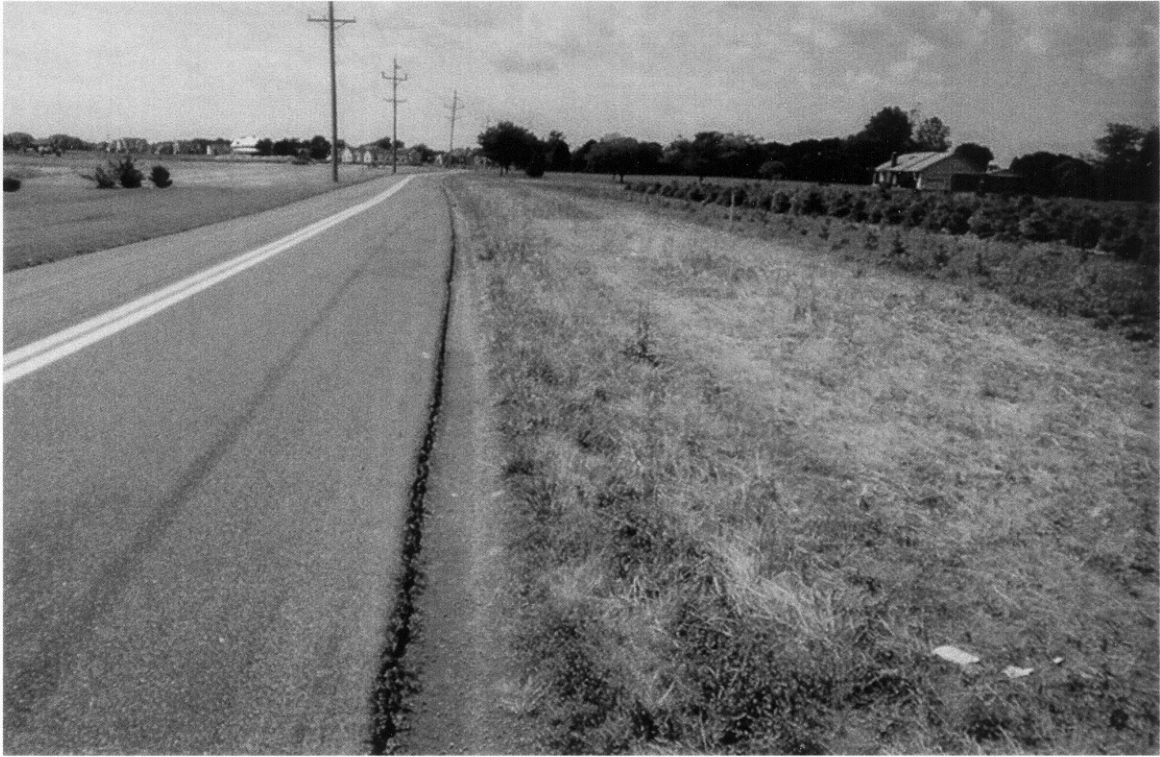
Pavement Drop-Off on Northbound Choptank Road, Approximately One Mile South of Churchtown Road

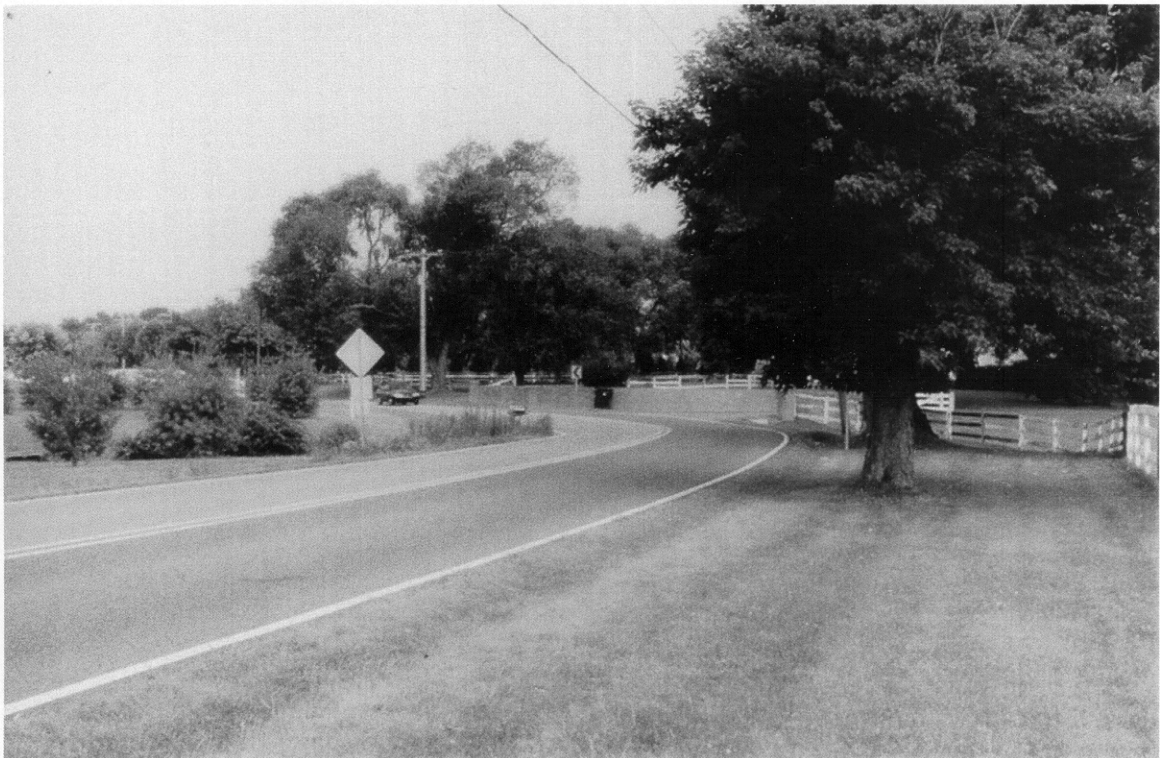
Horizontal Curve on Bunker Hill Road, West of Choptank Road.
